Manhole Inspection Summary

Manhole # S45I2_002MH

Insp Date: **11/12/08 2:52 PM**

Location Address: **1401 Church St.**

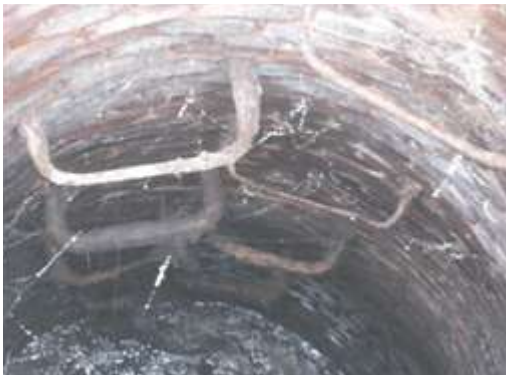
Steps

Count: **8** Missing: **1** ☒ **Corroded**

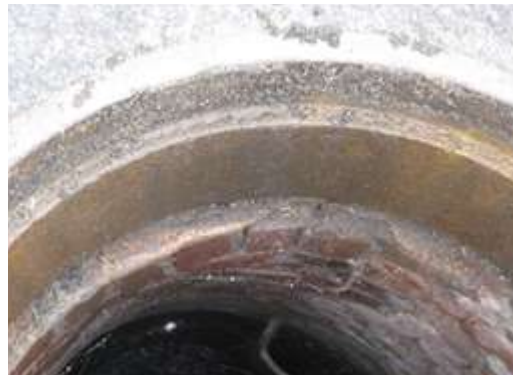
Defect 1

Offset: **1** (in.)

Frame offset

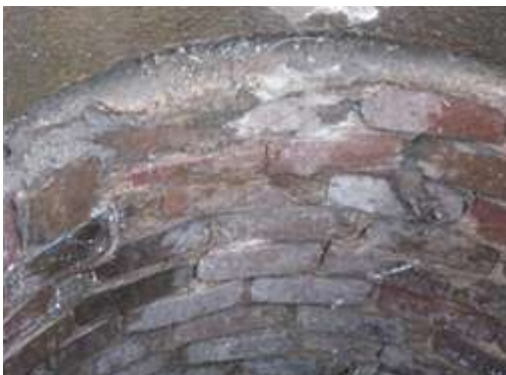
Defect 2

Missing step

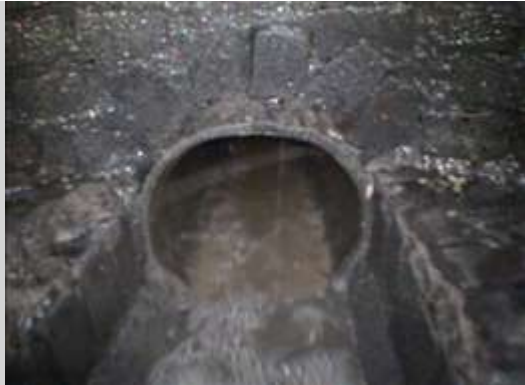
12 O'Clock Outflow

10 in. Circular Gravity Sewer
Pipe Out @ 12 O'Clock

Pipe Height: **10.8** (in.) Rod and Bar (Angled)
Pipe Material: **Clay** ☐ Pipe Lined
Invert Depth: **15.04** (ft.) Flow Characteristics: **Fast**
Deposits: ☒ None ☐ Mud ☐ Sludge ☐ Debris ☐ Grease
Silt Depth: (in.) Deposits Extent:
Infiltration: **None** Pipe Seal Cond: **Sound**

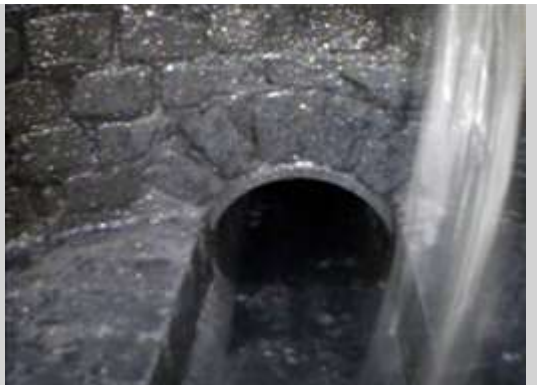
6 O'Clock Inflow

10 in. Circular Gravity Sewer
Pipe In @ 6 O'Clock

Pipe Height: **9.6** (in.) Rod and Bar (Angled)
Pipe Material: **Clay** ☐ Pipe Lined
Invert Depth: **14.98** (ft.) Flow Characteristics: **Fast**
Deposits: ☒ None ☐ Mud ☐ Sludge ☐ Debris ☐ Grease
Silt Depth: (in.) Deposits Extent:
Infiltration: **None** Pipe Seal Cond: **Sound**

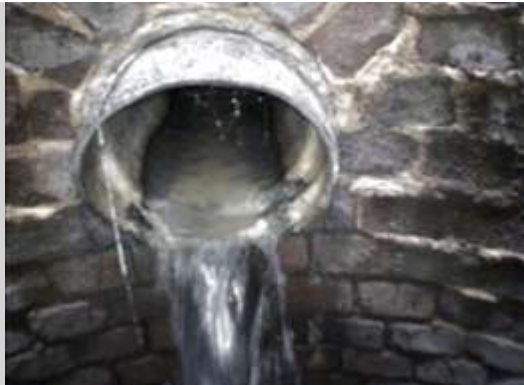
Pipe In @ 7 O'Clock

8 in. Circular Gravity Sewer

Infiltration: **Evidence** Pipe Seal Cond: **Cracked**

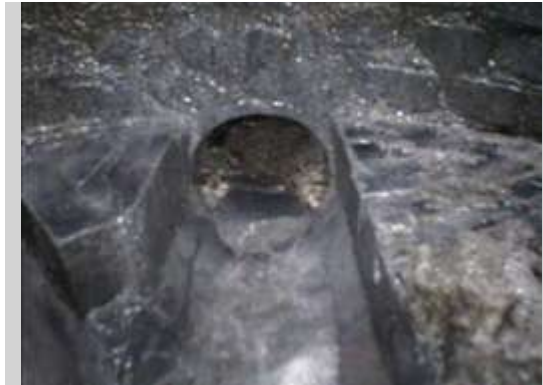
Drop In @ 7 O'Clock

Drop: **Outside** Rod and Bar

Drop Condition: **Clogged**
